**SAS Superstructure**

Daily Diary Report by Bid Item

Contract No.: 04-0120F4

Diary #: 570 Const Calendar Day: 973 Date: 08-May-2012 Tuesday

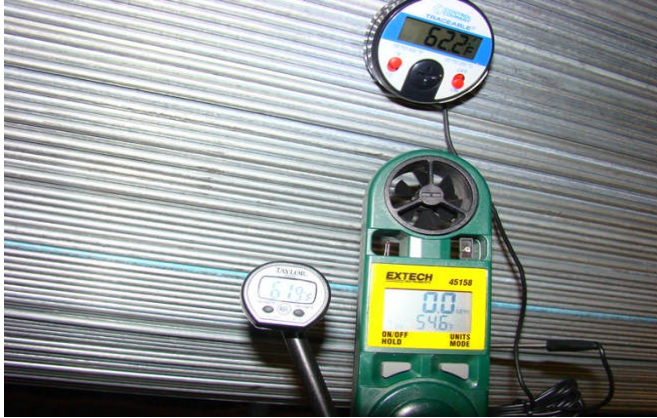
Ambient and steel temperatures measured approximately at cable band 44N on the south side of the cable just prior to starting the layout work.

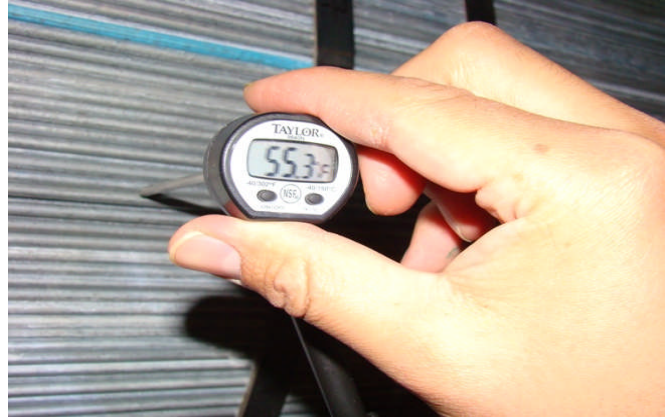
Measured steel temperature taken at cable band 64N Uphill.

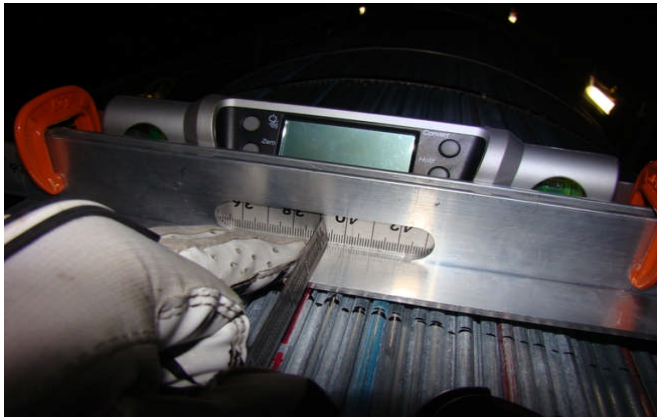
Close-up of a top dead center measurement taken at 62N Downhill where the diameter was 795mm and the distance from plumb was 4mm counter-clockwise east

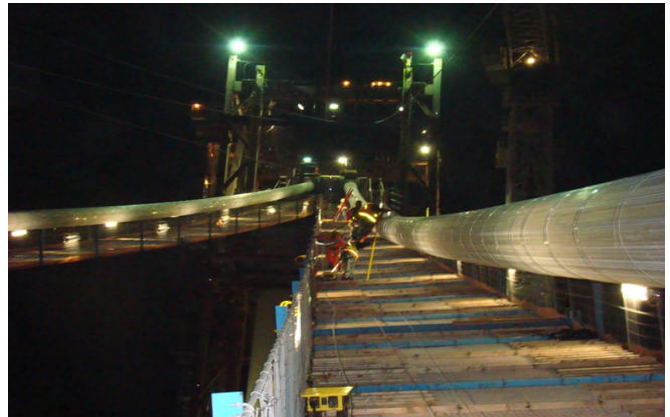
ABF and Caltrans crews laying-out and checking the rotational camber for the North Mainspan cable bands.

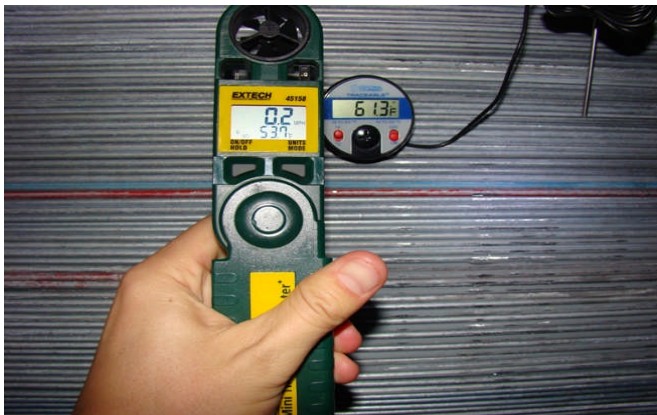
Ambient and steel temperatures measured approximately at cable band 108N on the north side of the cable just prior to starting the layout work.

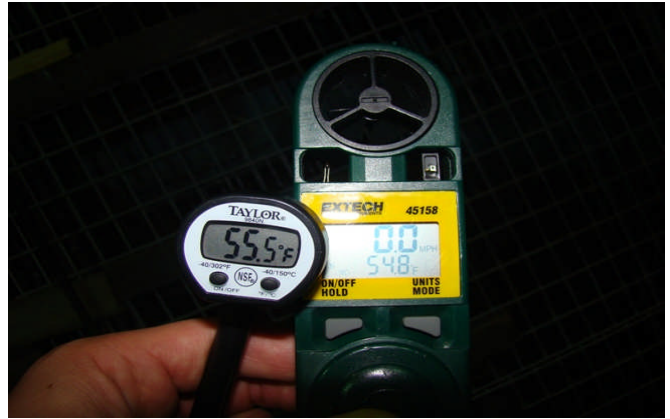
Check of the anemometer vs the other thermometer used to measure steel temperatures when measuring the ambient temperature only.

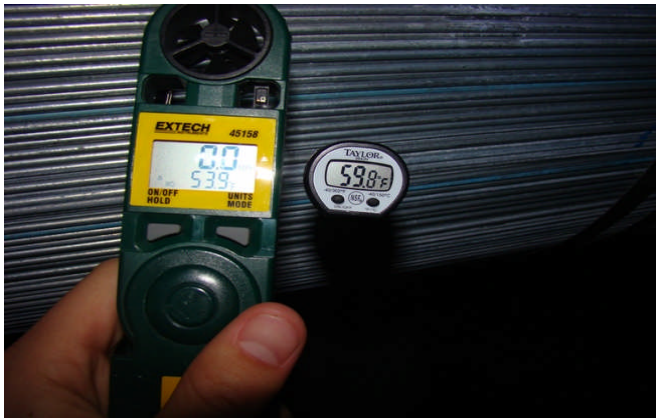
Ambient and steel temperatures measured approximately at cable band 108N on the south side of the cable just prior to starting the layout work.

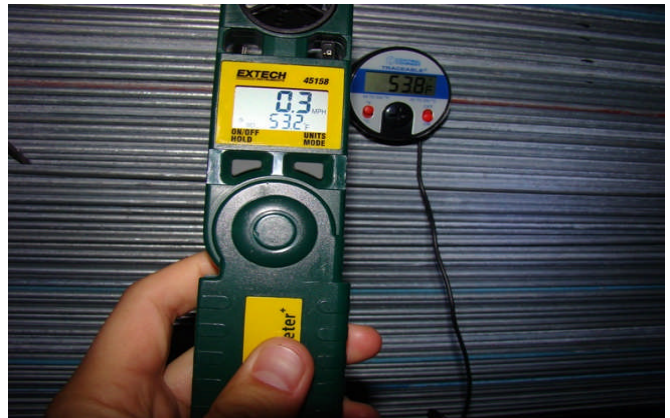
Check of the anemometer vs one of the thermometers used to measure steel temperatures when measuring the ambient temperature only.

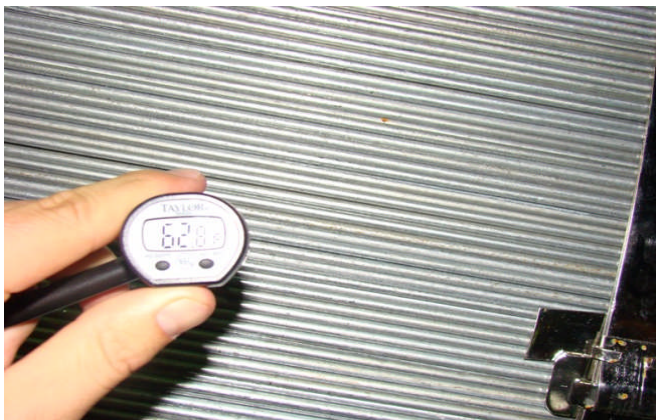
Steel temperature just prior to starting the layout work on the North Mainspan near cable band 44N after cautioning the ABF engineer.

The layout work was completed at 4:00am and I signed the ABF buy-off sheet at the end of the shift. Before the layout work commenced I cautioned ABF engineer Zach Lauria on prematurely starting until the ambient and steel temperatures matched each other. I made it very clear that any work performed where the temperatures weren't settled out would be done at their own risk. I also told him that some top dead center marks on the North Mainspan/Sidespan would be checked again at night and during the day to verify the correct positions. Also to gauge the behavior of the cable when subjected to thermal cycles. The sheet was signed due to the fact that the steel temperatures went down at the time of marking the top dead center of the North Mainspan cable.
